## In-line Piston Pin Circlip (PPC) Assembly Verification Solution Delivers 100% Reliable Error Proofing

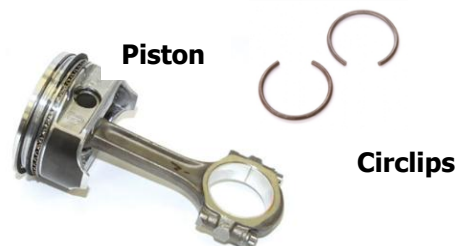
An automotive manufacturer used a 2D vision camera to inspect their piston pin circlip assembly, which failed when there were changes in ambient lighting or color changes between circlip and piston. They were looking for a solution that could provide 100% reliable error proofing and would not be affected by changes in lighting or part color.

2D Image	Robust3D Image	Conclusion
		<b>Circlip in Place</b> 
		<b>Circlip Missing</b>

To solve the auto customer's particular needs, Coherix developed a Robust3D PPC assembly error proofing solution based on its Tru3D sensor. Different from a temperamental 2D vision camera or a mechanical probe approach, the Coherix Robust3D PPC captures 3D data to create a 3D math model of the piston and circlip on each side of the piston. The Robust3D PPC delivered a 100% reliable error proofing solution.
